#### **TEST REPORT No. 368057**

glazed railing without handrail named "M10"

## resistance to horizontal linear static loading and dynamic loading in accordance with standard UNI 11678:2017

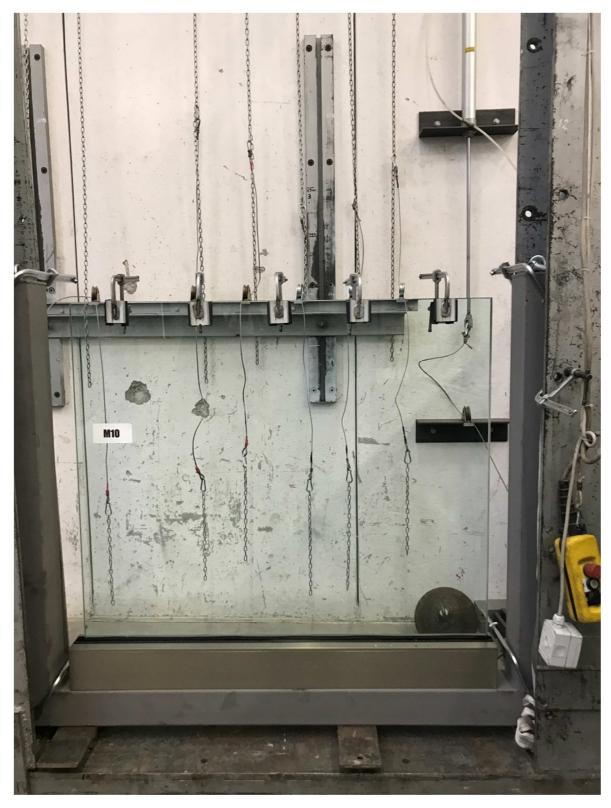
The item consists of a glass/aluminum railing without handrail with the following characteristics:

Item photograph

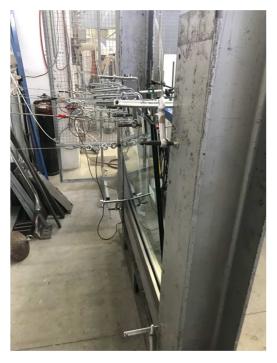
Photograph of the railing subjected to working load

Load step	Load	Duration	Deflection at the measuring points			Maximum allowed	Effect
			Α	В	С	deformation	
	[kN/m]	[min]	[mm]	[mm]	[mm]	[mm]	
preload	0,5	5	//	//	//	//	no damage
working load	1,0	5	38,5	40,0	39,0	≤100	no damage
load removal	0,0	//	6,5	6,6	6,8	≤10	//
ultimate load	1,5	5	//	//	//	//	no damage
breakage of internal glass pane							
collapse load after glass pane breakage	0,3	1	//	//	//	//	no collapse

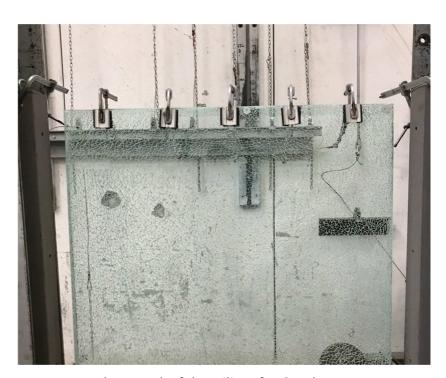
Photograph of the railing after breakage

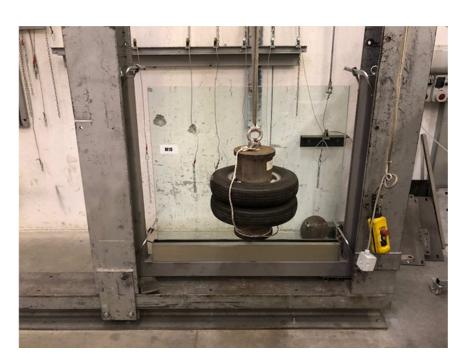
Photograph of the railing after double-tire body impact

Impact type	Impact area	Drop height	Impact energy	Effect
		[mm]	[1]	
	along the median 100 mm from the upper edge	1020	10	no damage
hard body	at infill centre	1020	10	no damage
	near to a fixing point	1020	10	no damage
de blacker	100 mm from top edge	700	350	no damage
double-tire body	at infill centre	700	350	no damage
body	250 mm from the corner along the bisectors	700	350	no damage
